# Photographic Record Cascade Mine Drainage

DSL-AMRB 91-001

Near Towns of Centerville, Stockett and Belt  
Cascade County, Montana

December, 1992  
Robert Peccia & Associates

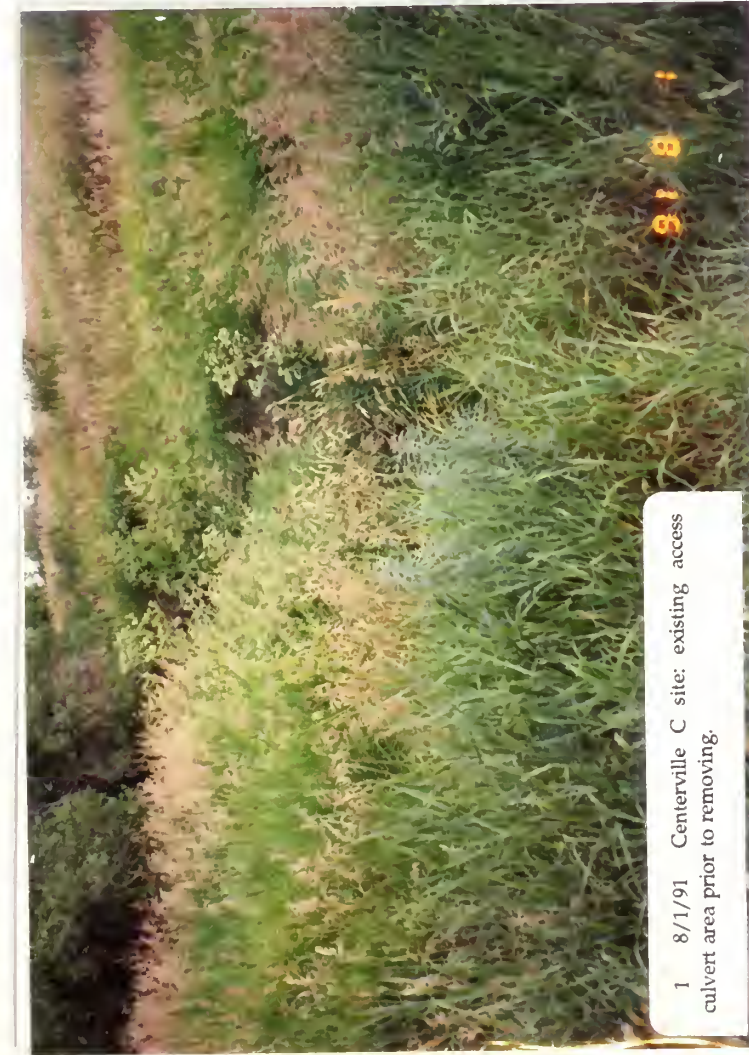
1 8/1/91 Centerville C site: existing access  
culvert area prior to removing.

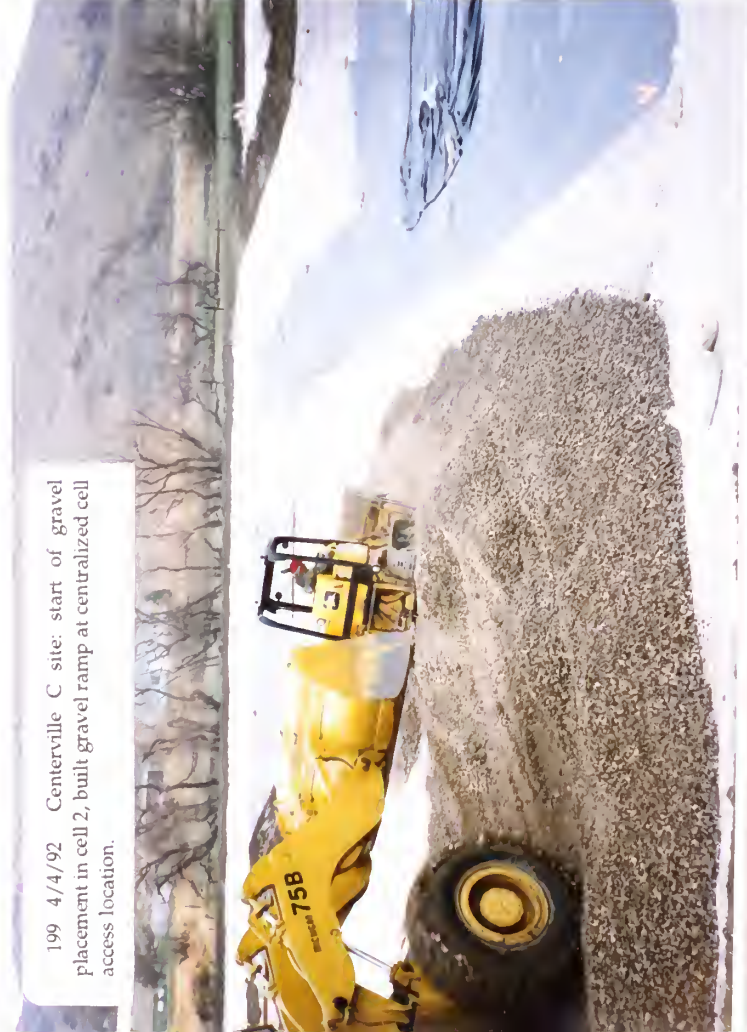
199 4/4/92 Centerville C site: start of gravel placement in cell 2, built gravel ramp at centralized cell access location.

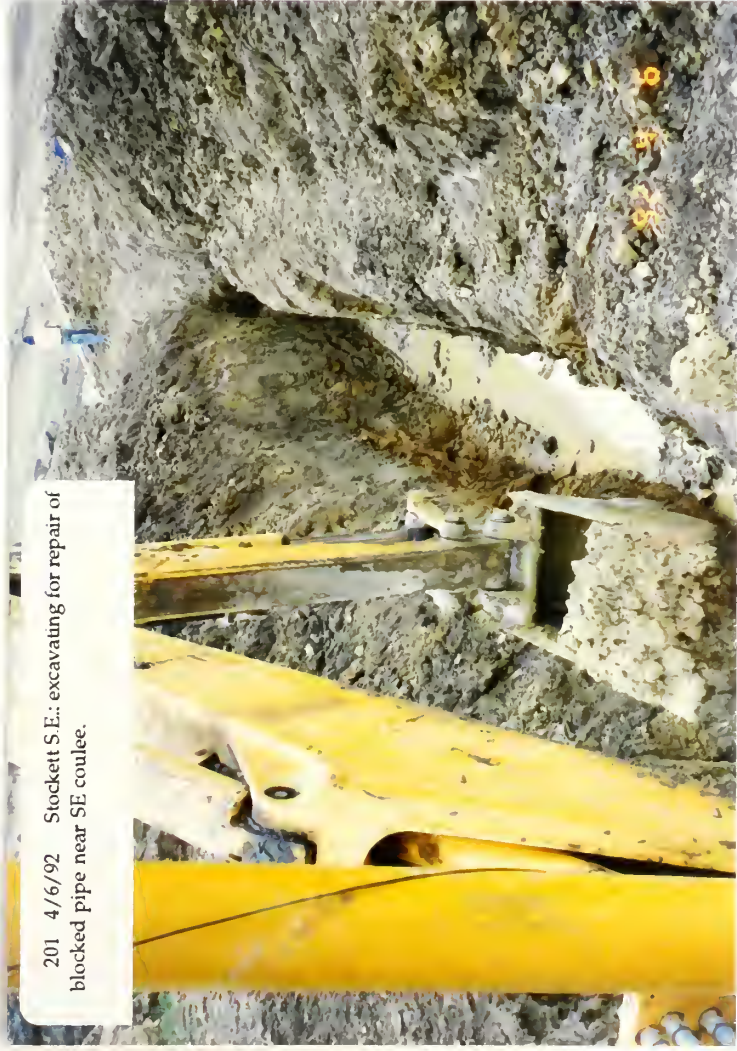
201 4/6/92 Stockett S.E.: excavating for repair of blocked pipe near SE coulee.

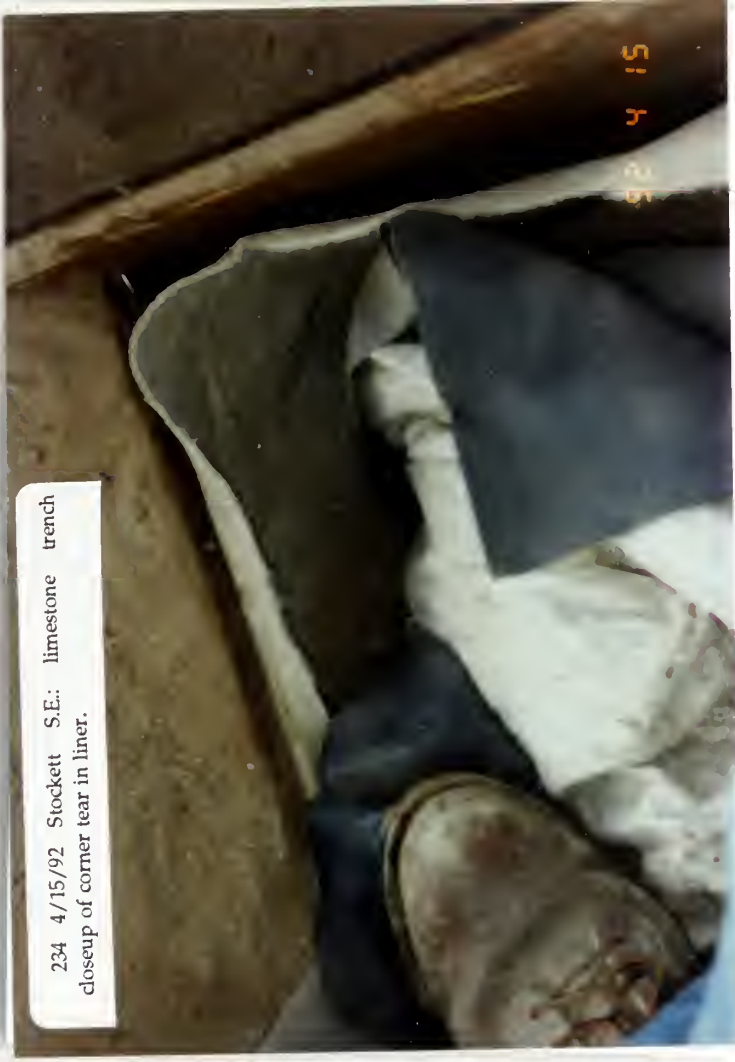
234 4/15/92 Stockett S.E.: limestone trench closeup of corner tear in liner.

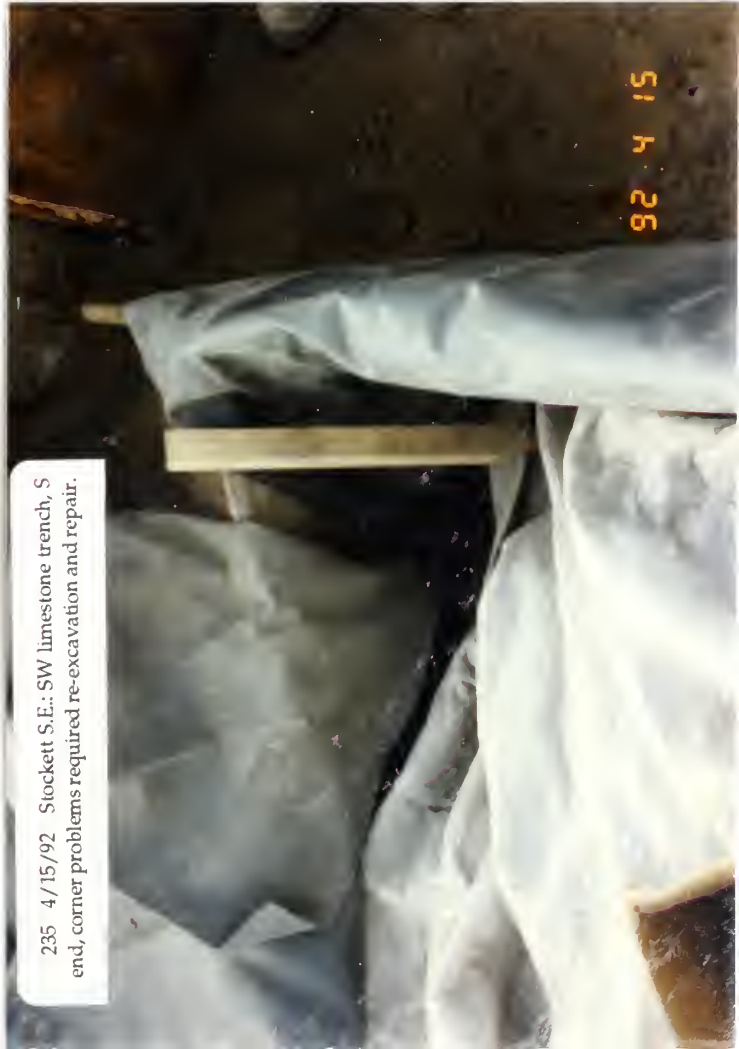
235 4/15/92 Stockett S.E.: SW limestone trench, S end, corner problems required re-excavation and repair.

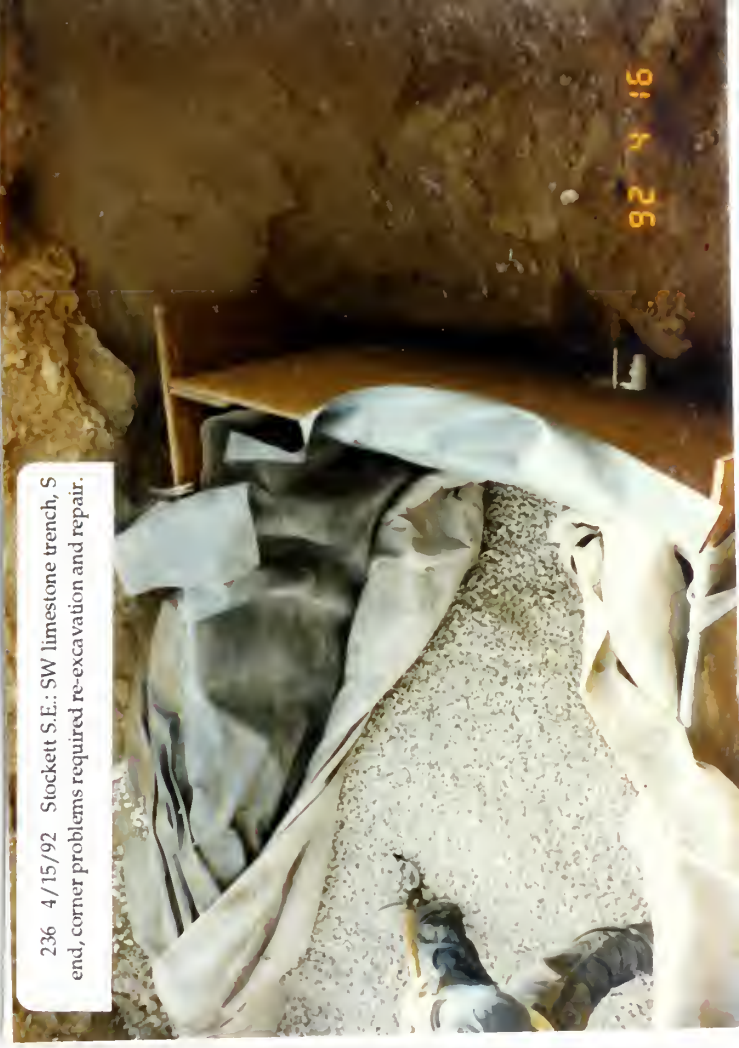
236 4/15/92 Stockett S.E.: SW limestone trench, S end, corner problems required re-excavation and repair.

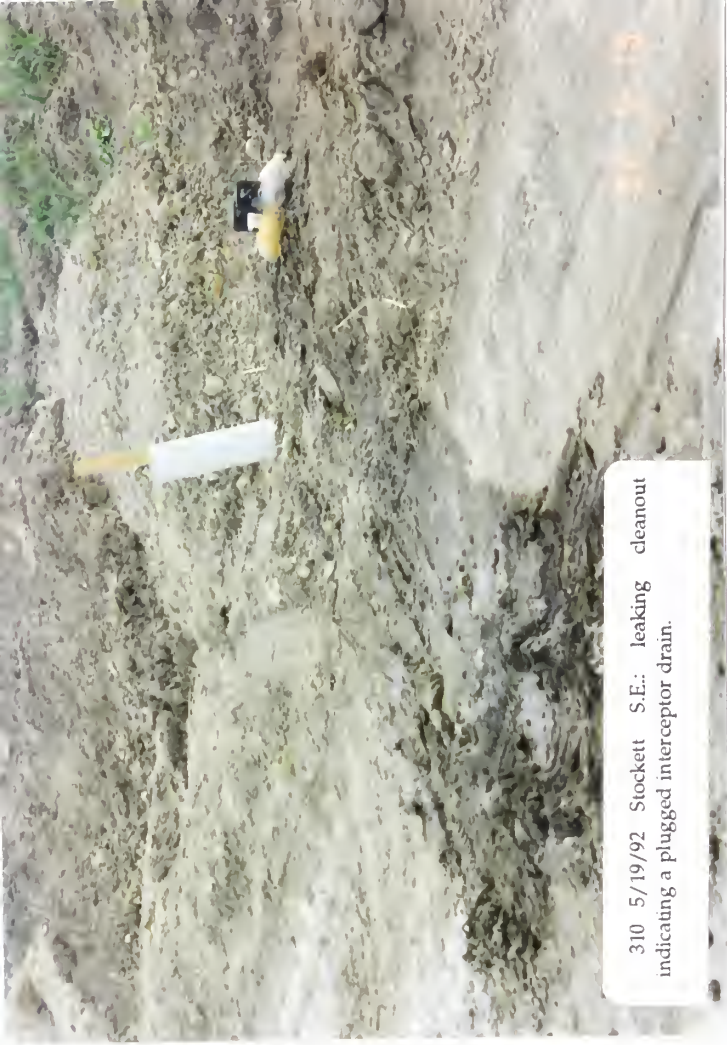
309 5/19/92 Stockett S.E.: leaking cleanout indicating a plugged interceptor drain.

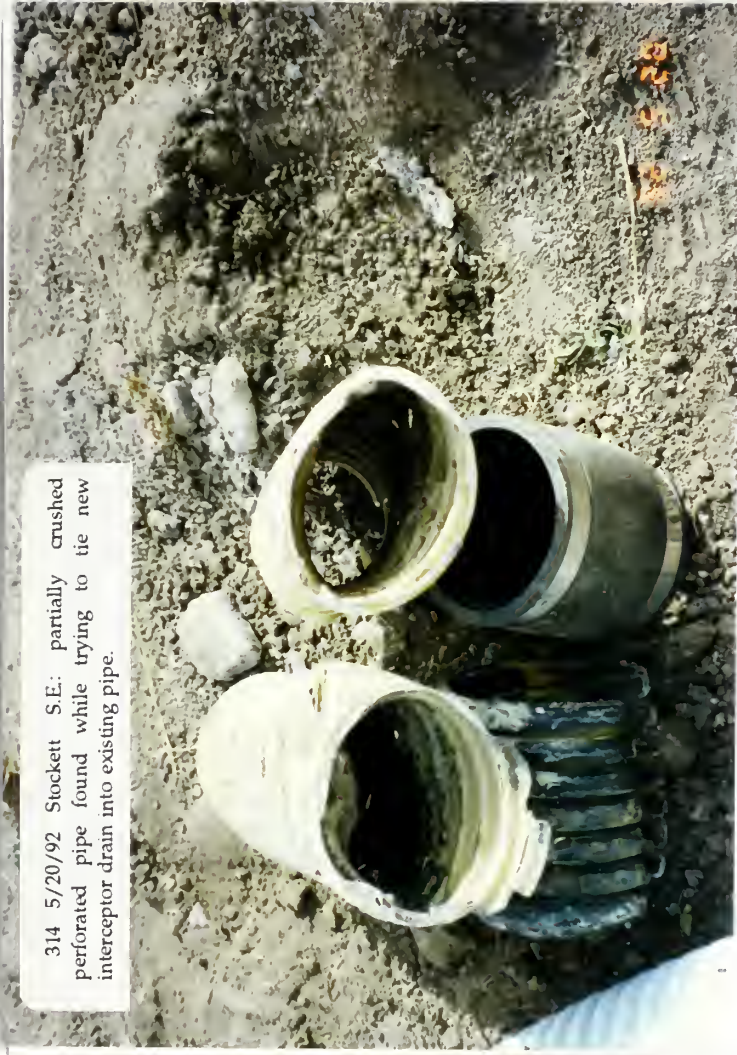
313 5/20/92 Stockett S.E.: partially crushed perforated pipe found while trying to tie new interceptor drain into existing pipe.

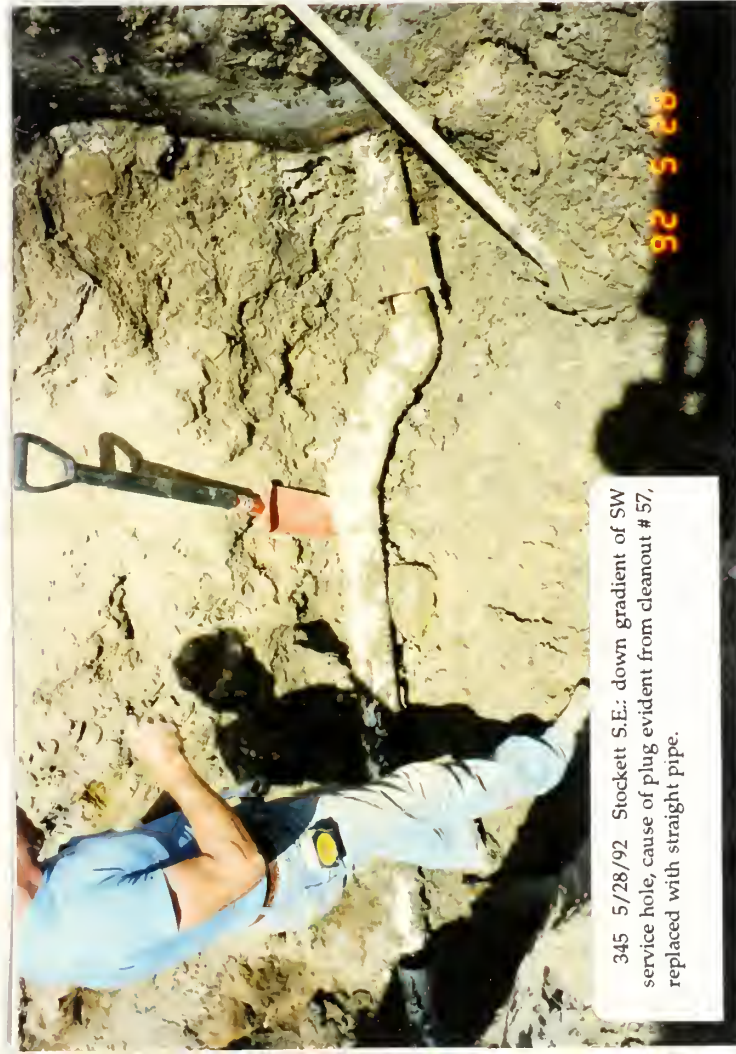
345 5/28/92 Stockett S.E.: down gradient of SW service hole, cause of plug evident from cleanout # 57, replaced with straight pipe.

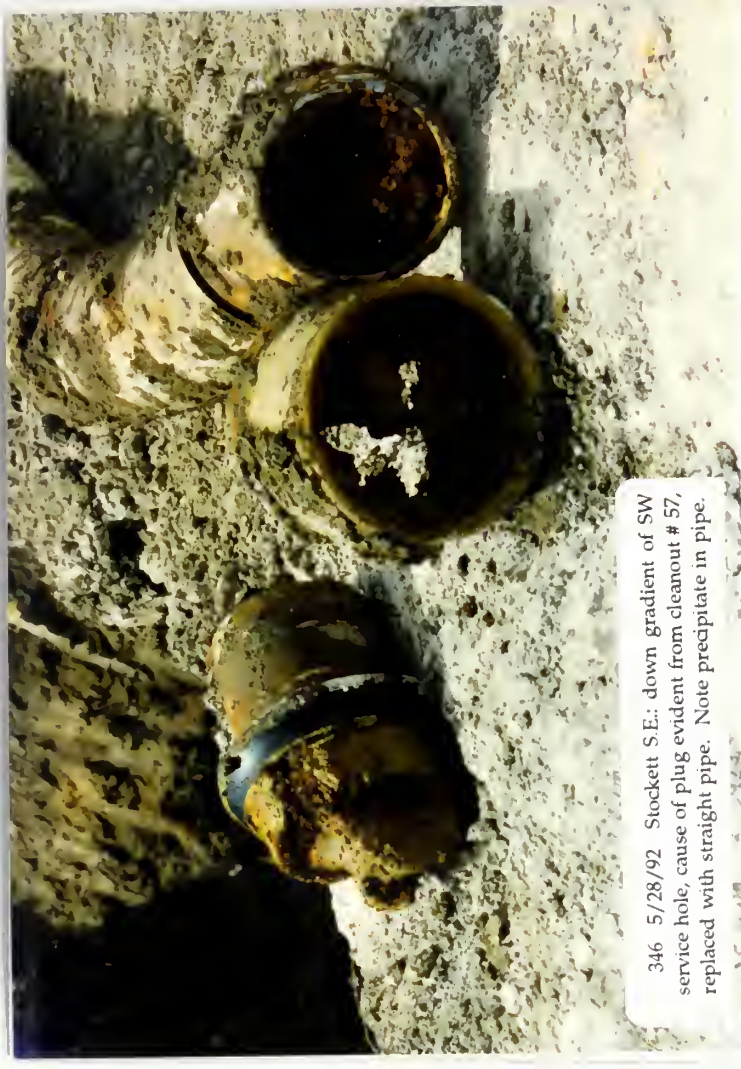
346 5/28/92 Stockett S.E.: down gradient of SW service hole, cause of plug evident from cleanout # 57, replaced with straight pipe. Note precipitate in pipe.

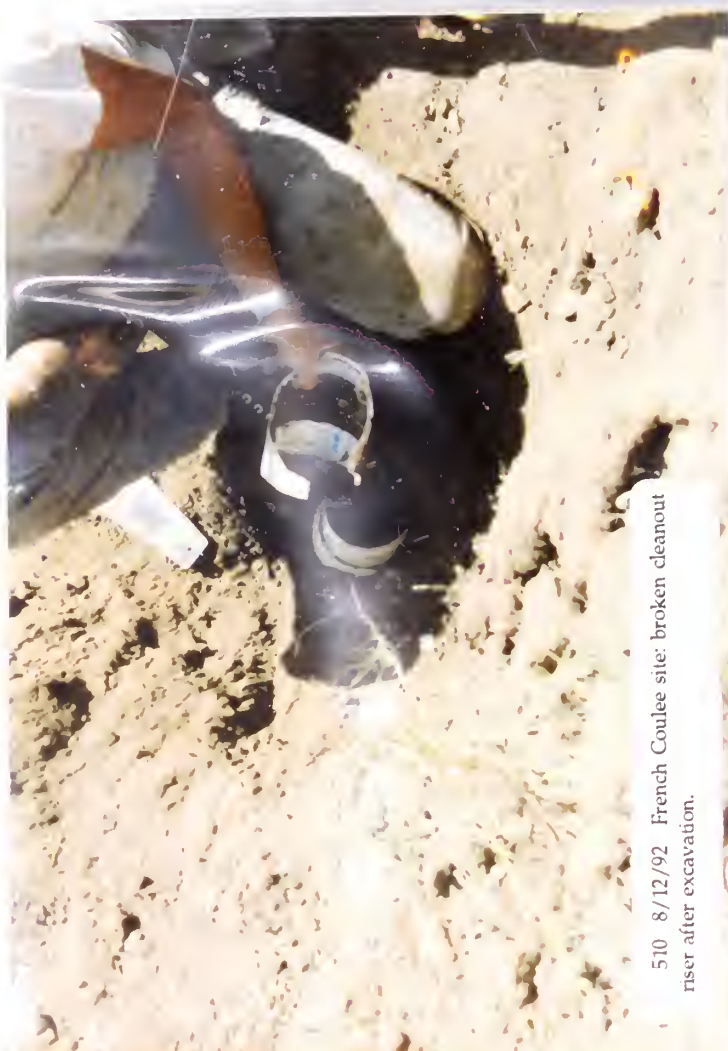
510 8/12/92 French Coulee site: broken cleanout riser after excavation.
